US Army Corps
of Engineers
Waterways Experiment
Station

Corps of Engineers Structural Engineering Conference

8-12 July 1991

Volume II

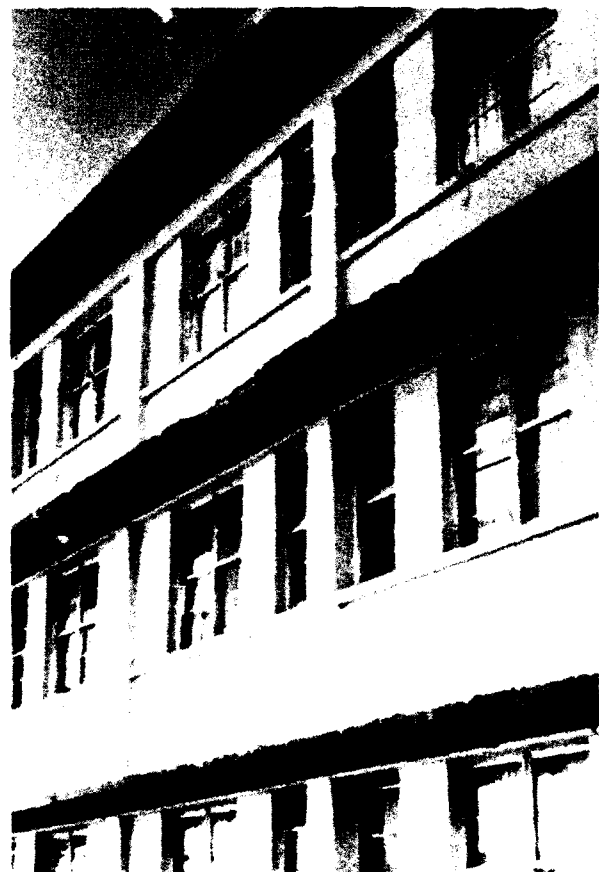
Figure 3. Building 338: Concrete deterioration at building overhangs

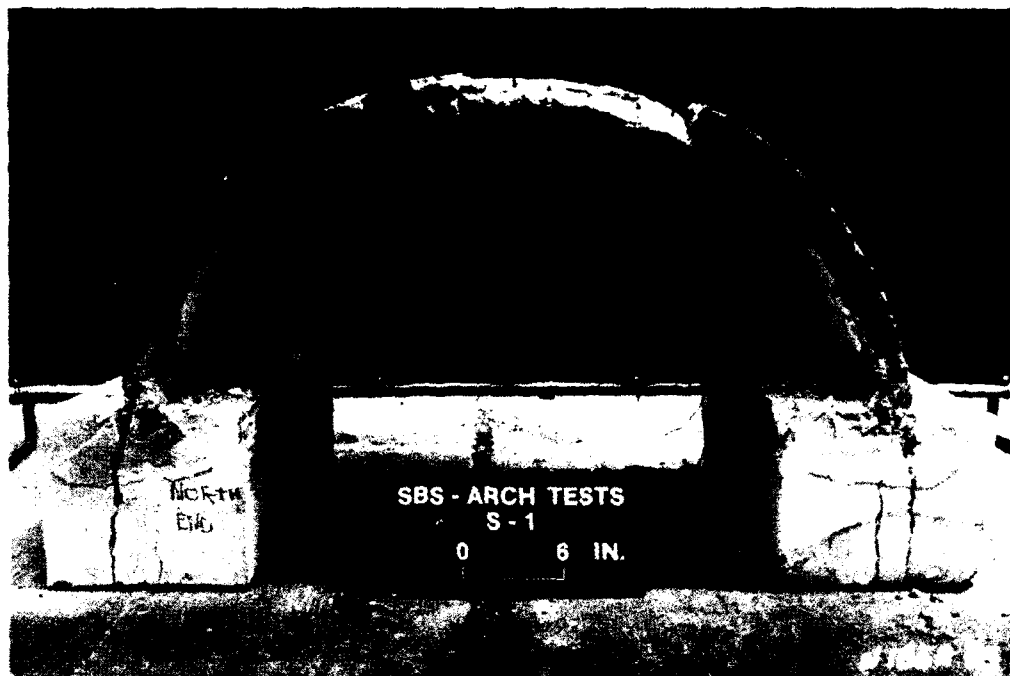
Figure 4. Posttest view of north end of arch S-1

Posttest photographs of arch S-1 are shown in Figures 4 and 5. The crown deflection relative to the footings was about 2-3/4 in. The average rigid body displacement, obtained by averaging the downward displacement of the footings at the four corners of the structure, was about 1/4 in. Each of the footings rotated inward about 1.5 deg. Small tension cracks occurred on the outside and crushing and spalling occurred on the inside of the arch ring at about +45 and -45 deg and extended the entire length of the arch, indicating flexural behavior at these locations. On the west side, a large crack ran the length of the arch. At the north end, the crack was located at about -30 deg and it ran downward in a zigzag pattern to the other end where it ended at about -80 deg. Some local buckling of the reinforcing bars was evident at this crack. At the north end of this crack the arch ring appeared to have sheared through and slipped to where the two sections were overlapping. Small tension cracks were visible on the interior of the arch at the crown, and a small amount of concrete crushing was visible on
